Manhole Inspection Summary

Manhole # S45GG_062MH

Insp Date: **2/17/10 11:59 AM**

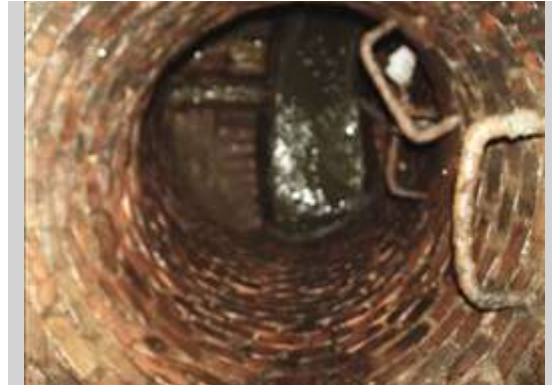
12 O'Clock Outflow
Pipe Out @ 12 O'Clock

Pipe Height: **21.6** (in.) Rod and Bar (Angled)
Pipe Material: **Clay** ☐ Pipe Lined
Invert Depth: **12.50** (ft.) Flow Characteristics: **Slow**
Deposits: ☒ None ☐ Mud ☐ Sludge ☐ Debris ☐ Grease
Silt Depth: (in.) Deposits Extent:
Infiltration: **None** Pipe Seal Cond: **Sound**
